Archaeological Study Confirms Location of Bozori Sanduq Hammam in Samarkand

Fatima Khudaikulova

Independent researcher of Silk Road International research institute

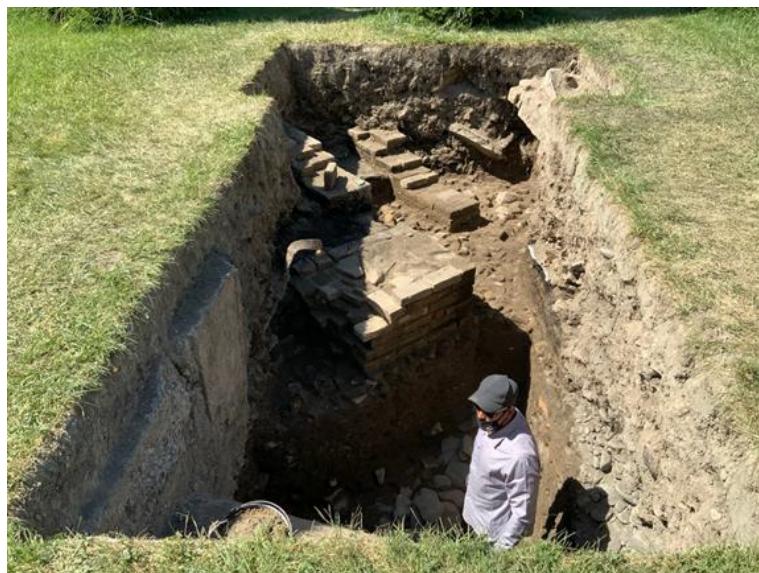
Figure 1. Excavation trench 1 showing preserved wall foundations and furnace zone with ash deposits, confirming the geophysical anomalies and providing direct evidence of the hammam’s heating system (photo by Khudaykulova F., 2020).

The research into the Bozori Sanduq hammam confirmed the survival of substantial underground remains, including thick masonry walls exceeding one meter in width, internal partitions, furnace zones with ash deposits, and collapsed dome fragments. Stratigraphic analysis revealed multiple phases of construction, use, and reconstruction, as evidenced by differences in brick typology—from traditional square medieval bricks to 19th–20th century industrially produced ones. This layering reflects both the continuity of function and the adaptive reuse of the bathhouse over centuries, a feature consistent with theoretical models of urban resilience in historic cities. The identification of a cobbled road oriented toward Ulughbek’s madrasa further anchors the hammam within Samarkand’s civic and spatial network, illustrating its integration into the functional core of the city.

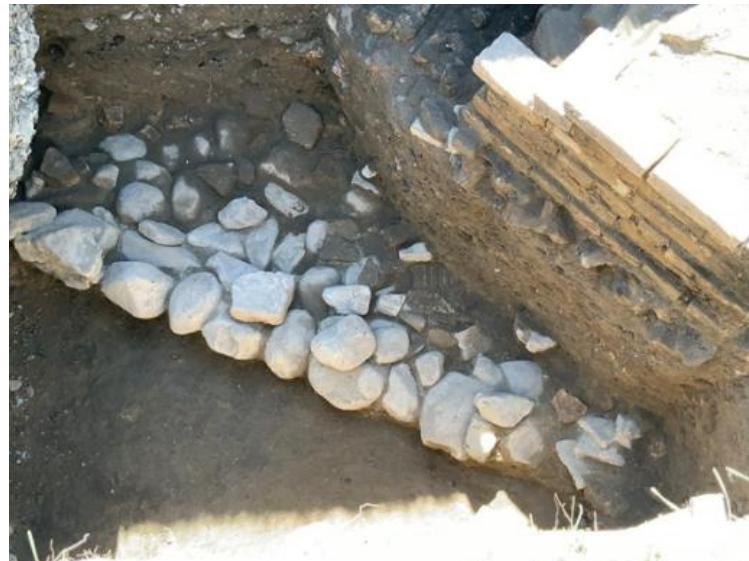
Figure 2. Cobbled road pavement dated to the 17th century – highlights stratigraphic context and urban connectivity, anchoring the hammam within Samarkand's civic landscape.

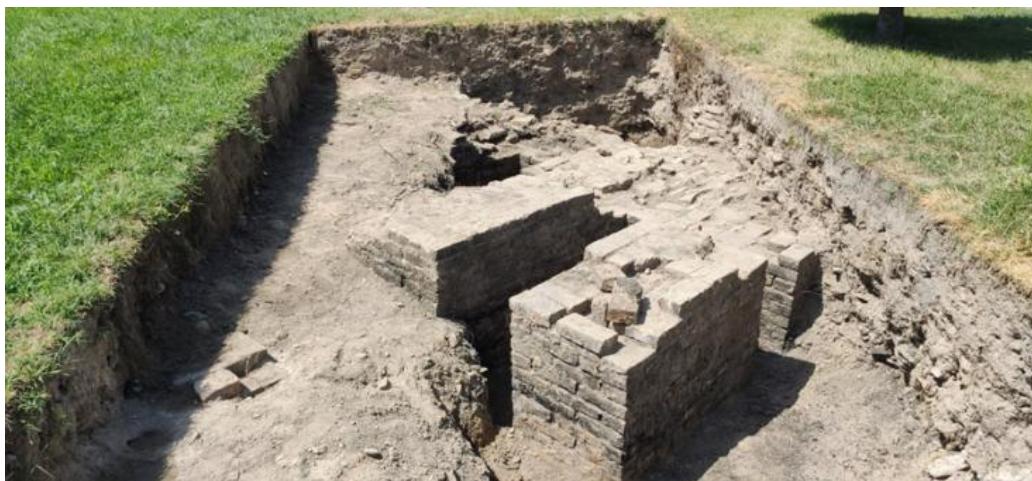
Figure 3. Excavation trench 3 with collapsed dome fragments and associated wall remains, illustrating the architectural features of the Bozori Sanduq hammam and evidence of its destruction in the 20th century (photo by Yanbukhtin I., 2020).
